THE STABILITY OF NATURAL SLOPES IN THE MACKENZIE VALLEY

J.A. Code

Terrain Sciences Division
Geological Survey of Canada

July 1973

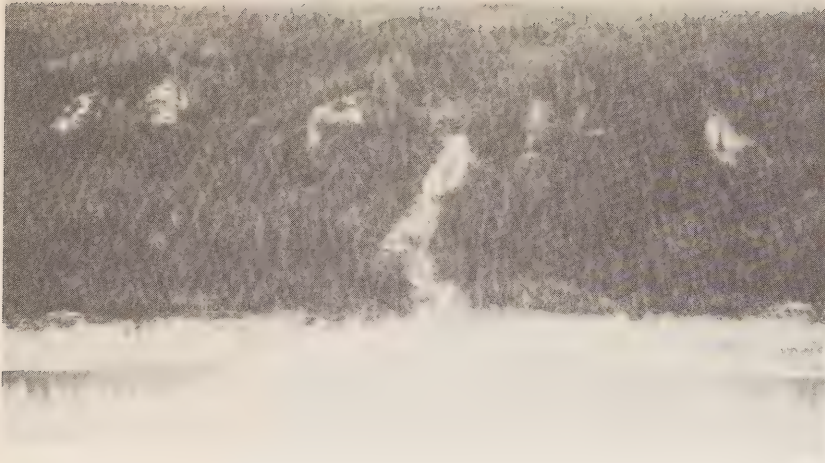
Figure 1 Earthflow, elongate (Qa) Mackenzie River, north of Wrigley.

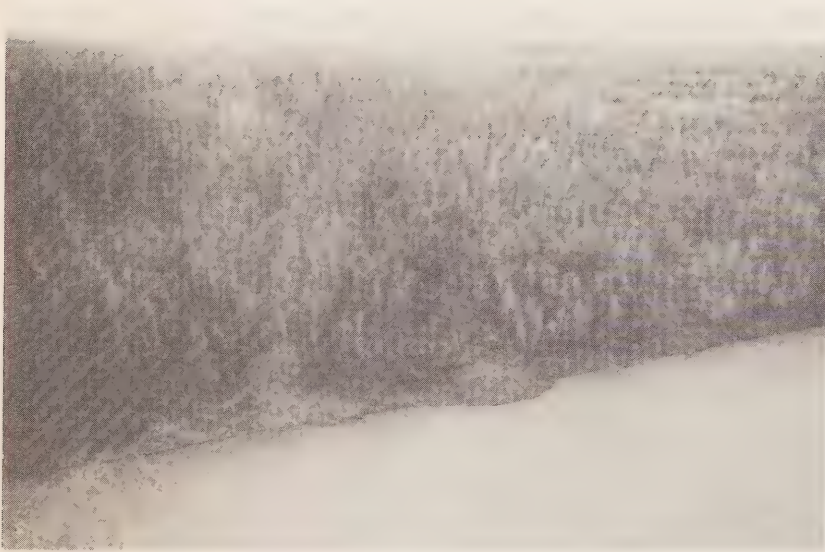
Figure 2 Earthflow, lobate (Qa) Mackenzie River, north of Fort Simpson.

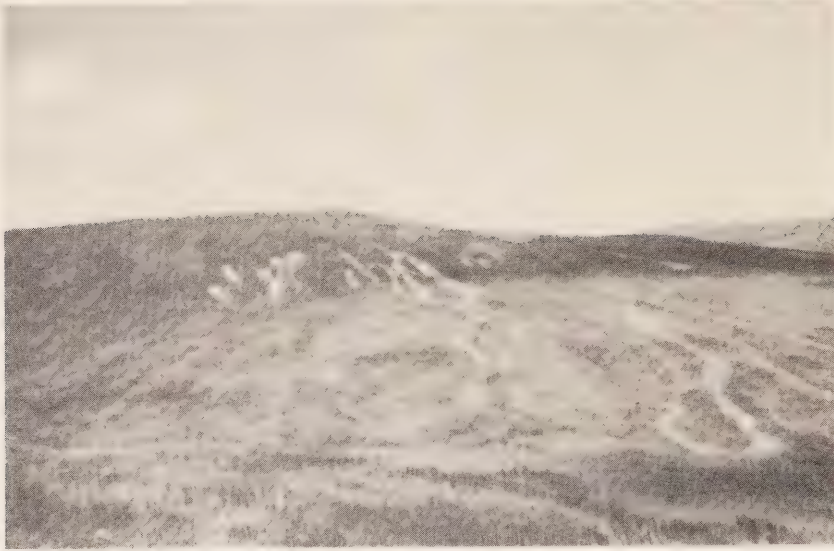
Figure 3 Earthflows in recently burnt area west of Wrigley (Qa).

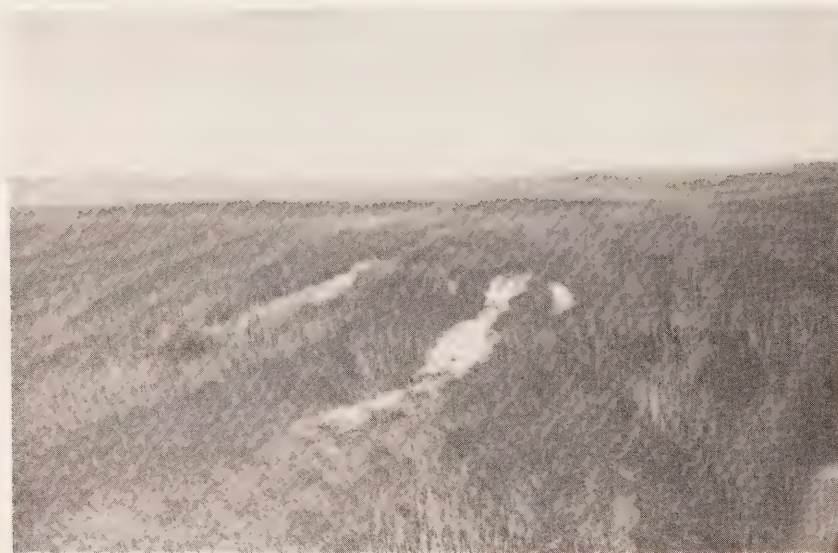
Figure 4 Closer view of Figure 3.

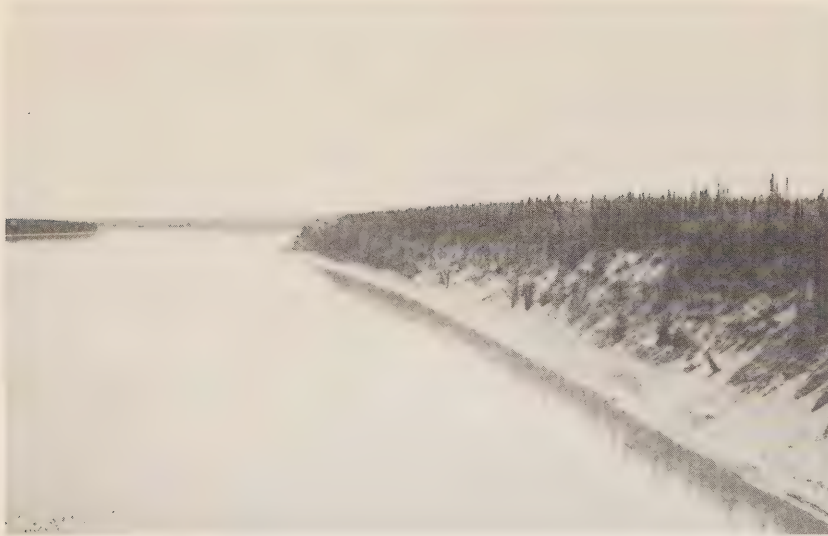
Figure 5 Detachment slides in granular soil (Qa) Mackenzie River near Blackwater River.

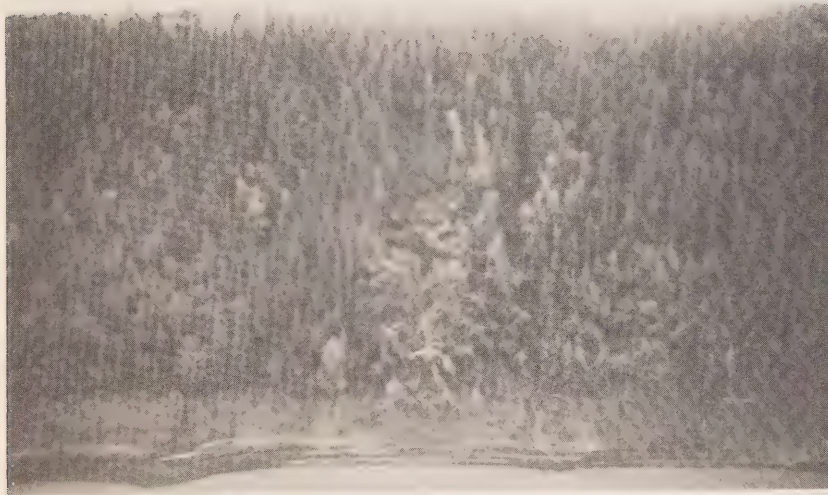
Figure 6 Detachment slide in Cretaceous shale (Ka).

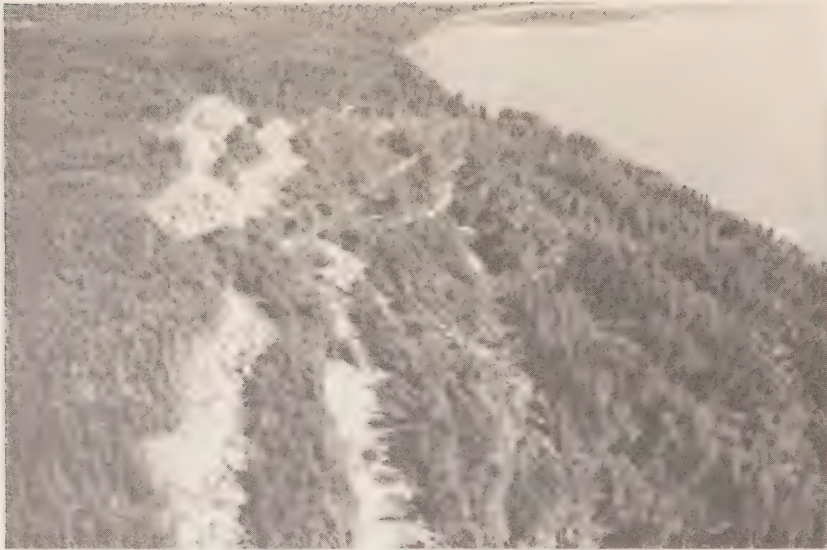
Figure 7 Large scale retrogressive slide; (Q1) Mackenzie River near Root River.

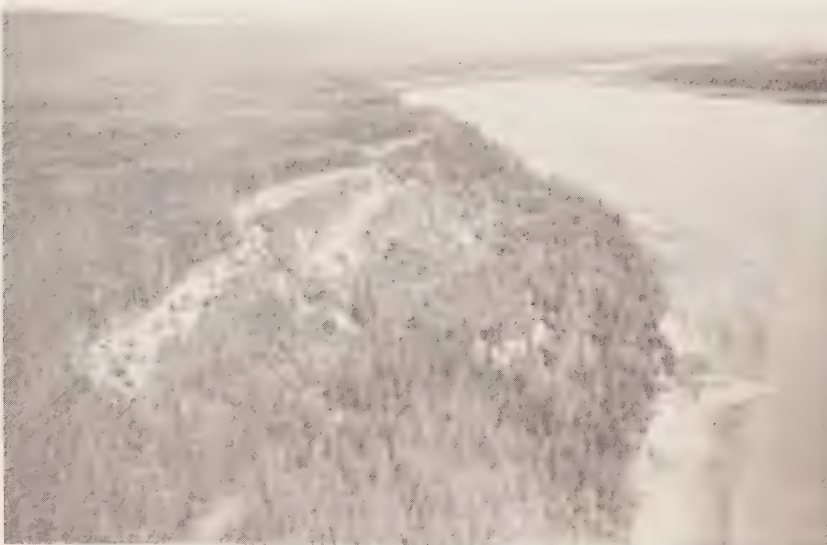
Figure 8 Large scale retrogressive slide; (Q1) Mackenzie River near Root River.

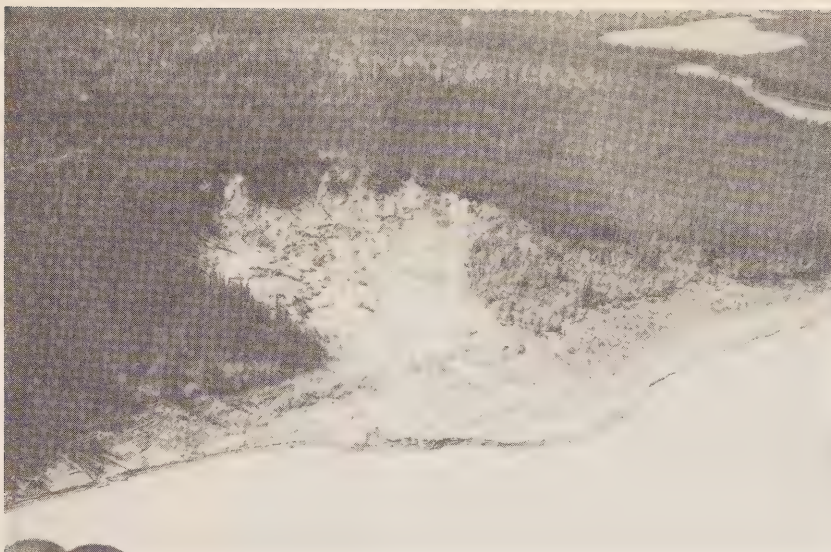
Figure 9 Large scale retrogressive failure; Quaternary sediments (Q1) Mackenzie River opposite Fort Norman.

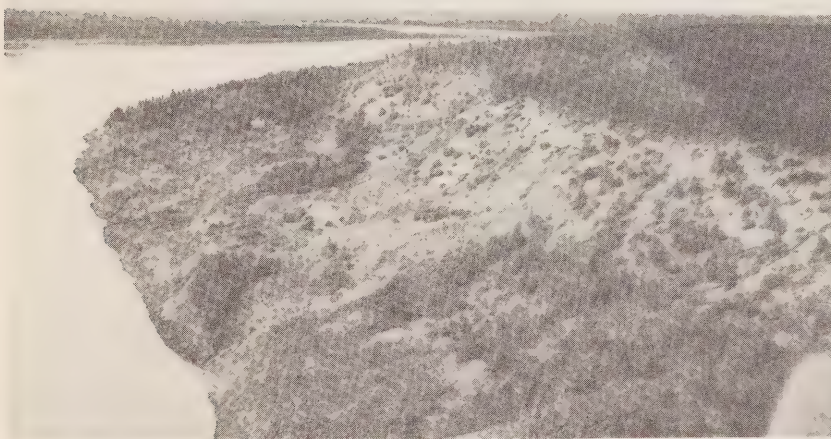
Figure 10 Large scale retrogressive slides, Quaternary sediments (Q1) Mackenzie River south of Fort Norman.

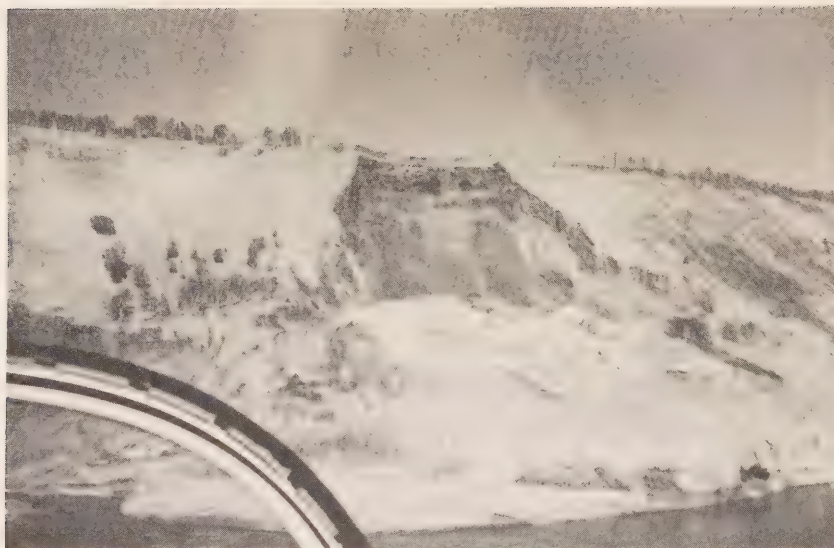
Figure 11 Large scale retrogressive failure in Cretaceous shale (K1) Arctic Red River.

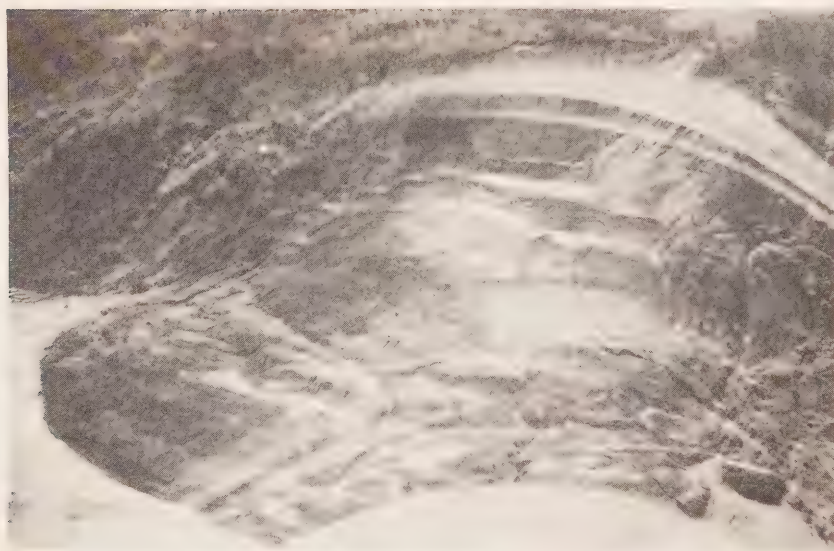
Figure 12 Large scale retrogressive failure in Cretaceous shale (K1) Mountain River.

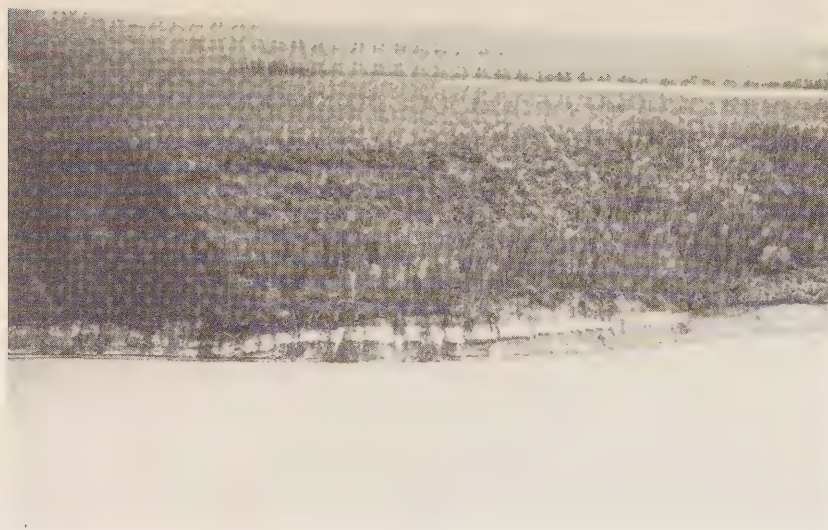
Figure 13 Large scale slumping in Tertiary sediments (Te)
Mackenzie River south of Fort Norman.

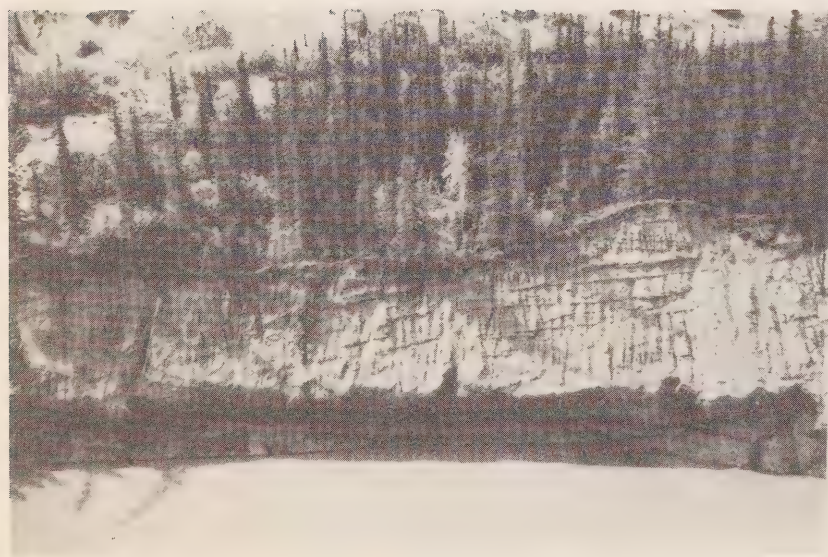
Figure 14 Undercutting of detached frozen slumped block (Q1)
Mackenzie River north of Sans Sault Rapids.

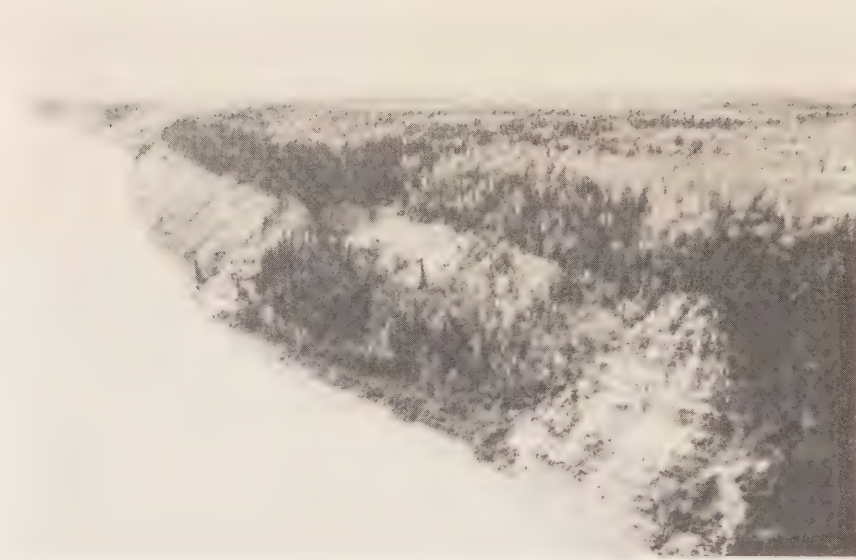
Figure 15 River bank in Devonian sediments (D) Liard River.

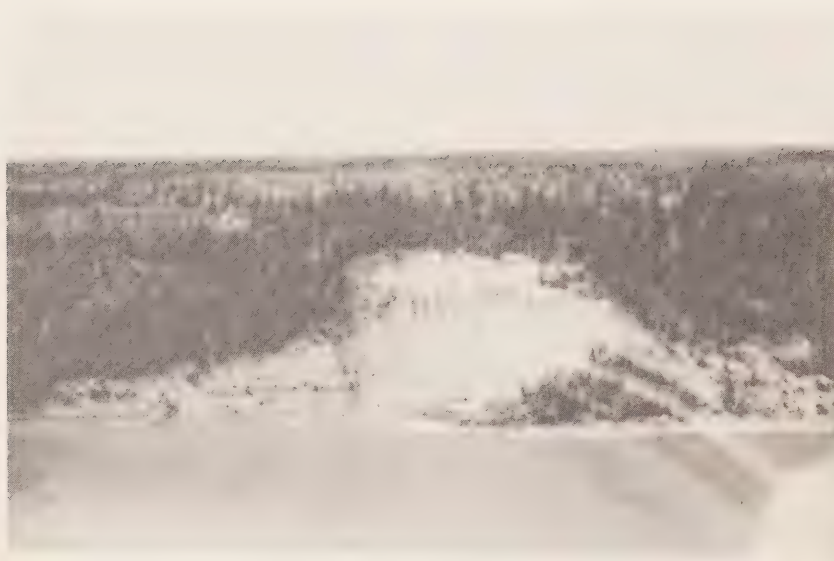
Figure 16 Slump in Devonian sediments (D) Liard River.

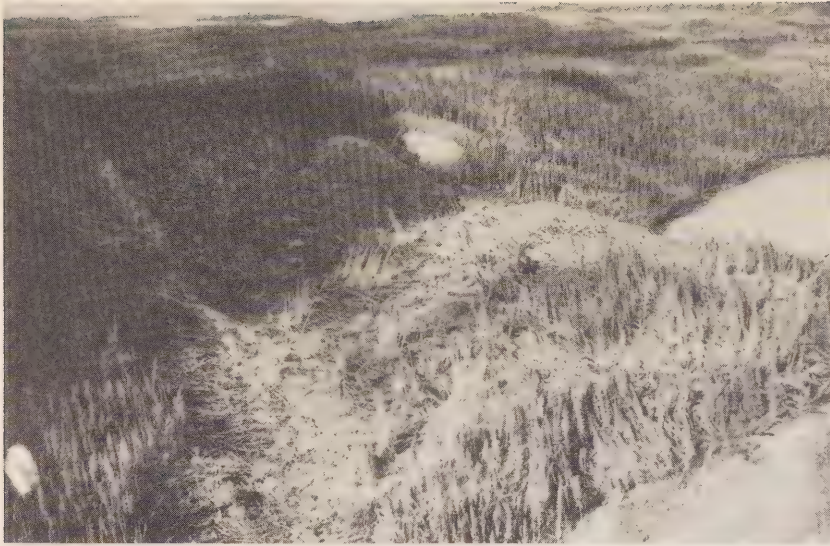
Figure 17 Large scale multiple retrogressive slide (Q1)
Mackenzie River north of Fort Simpson.

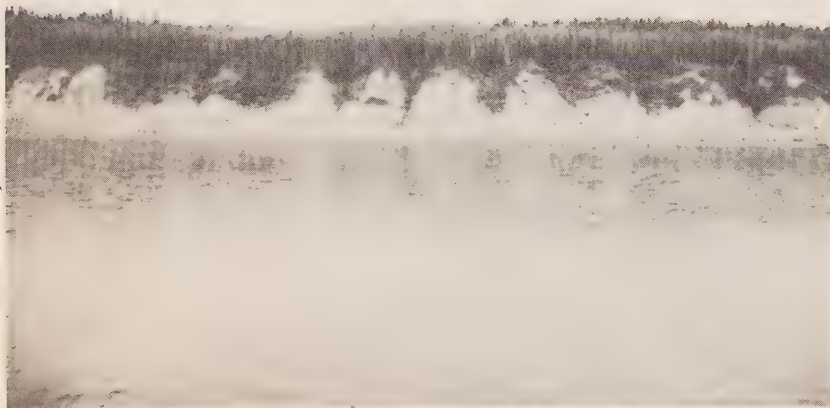
Figure 18 Gullying in glacial till (Qa) Mackenzie River
south of Fort Simpson.
